Subsurface Void Detection for the Foundation Performance Association

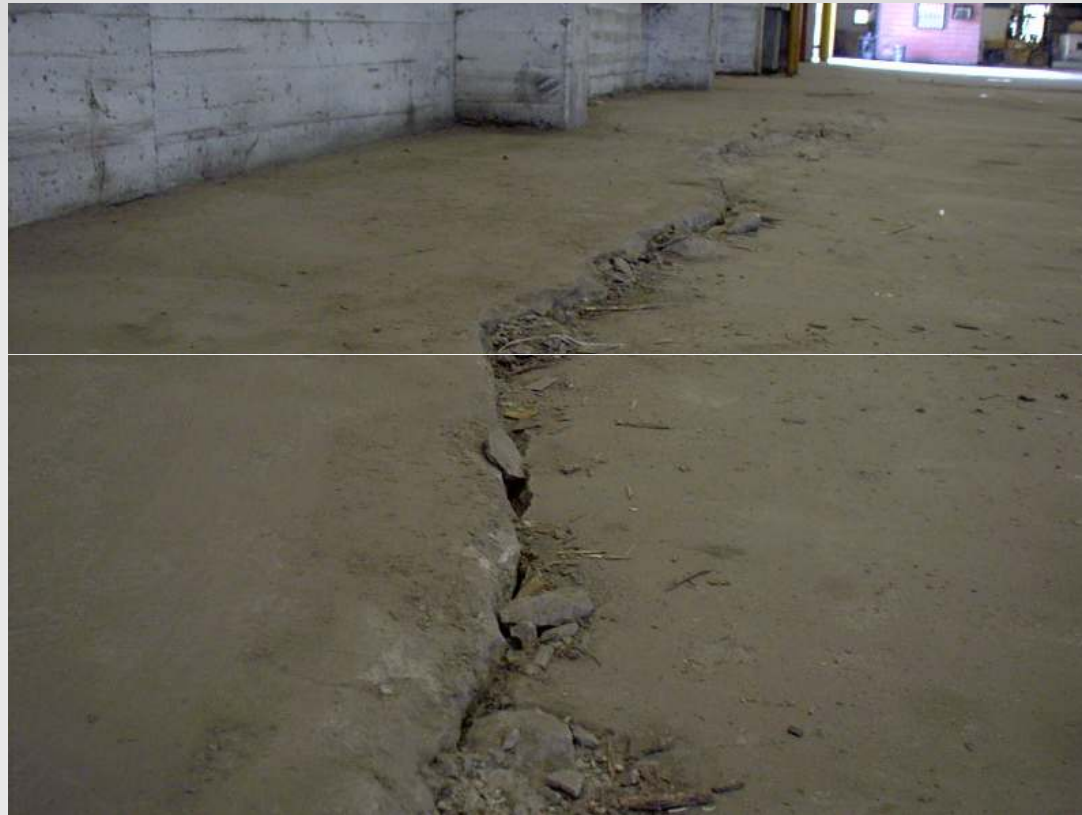
Slab failure near exterior grade
beam due a large void.

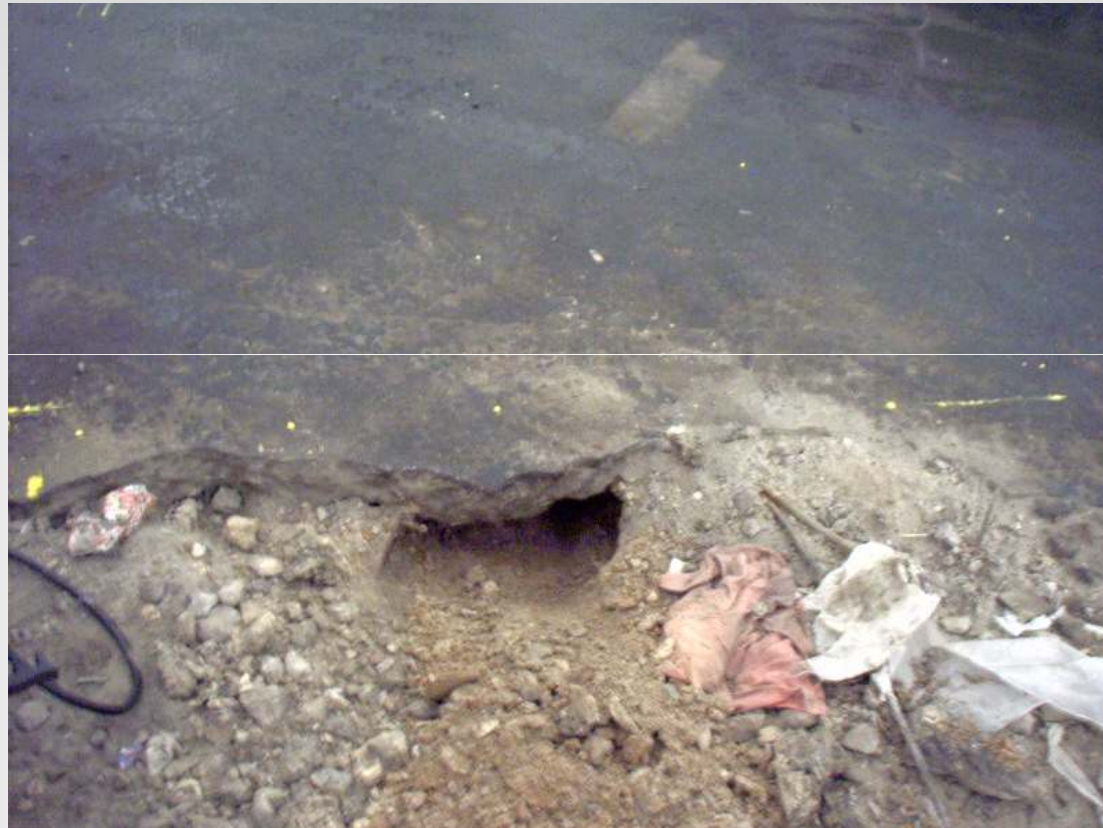
**Known Void vertical depth:
Approximately 3" as measured**

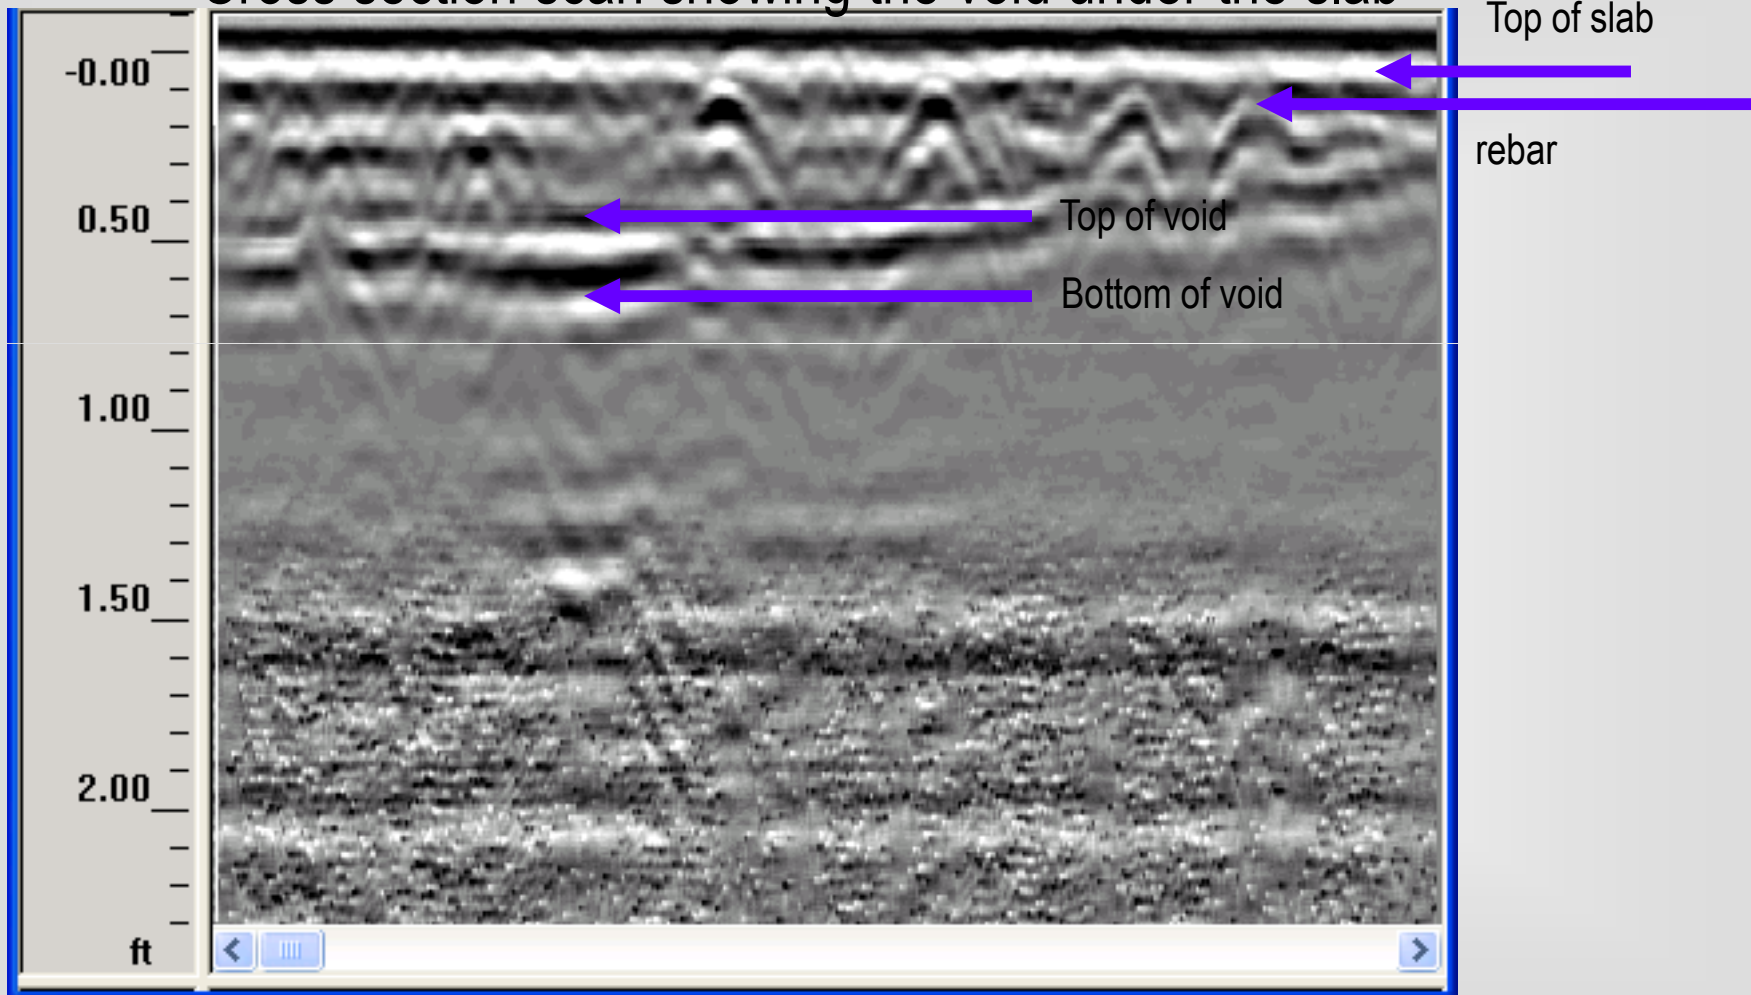
Cross section scan showing the void under the slab

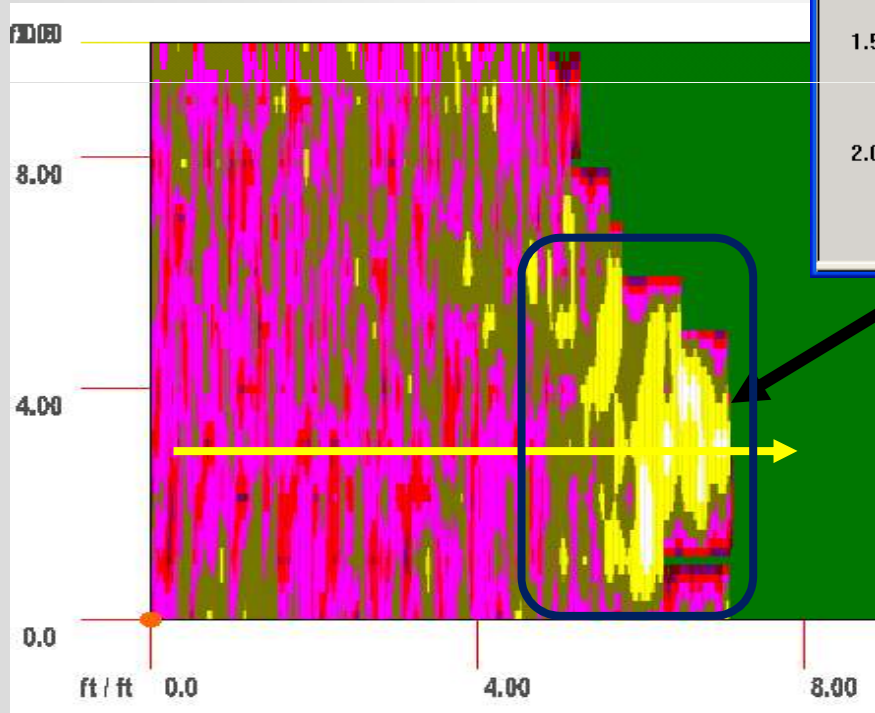
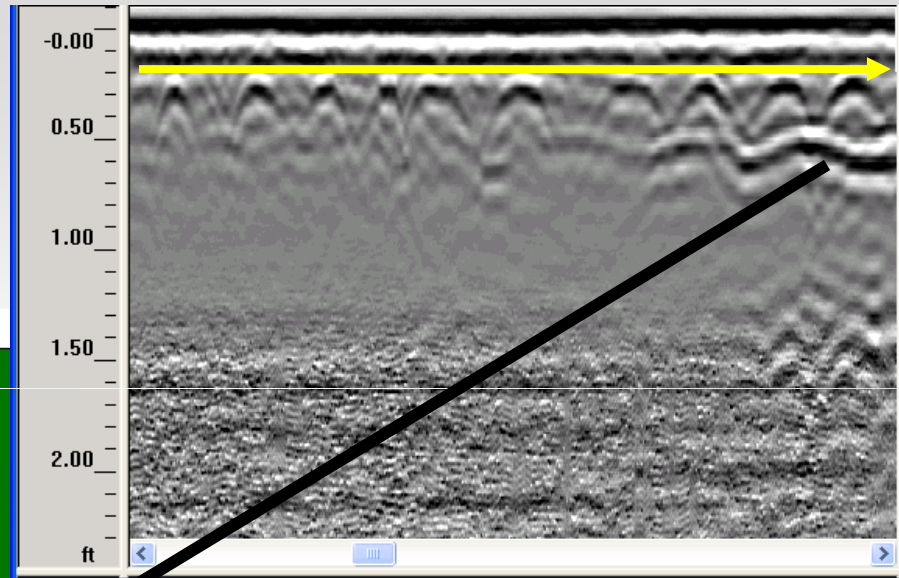
Cross section scans
merged into plan view
to show the void.

Dark blue outline indicates the
area of the void

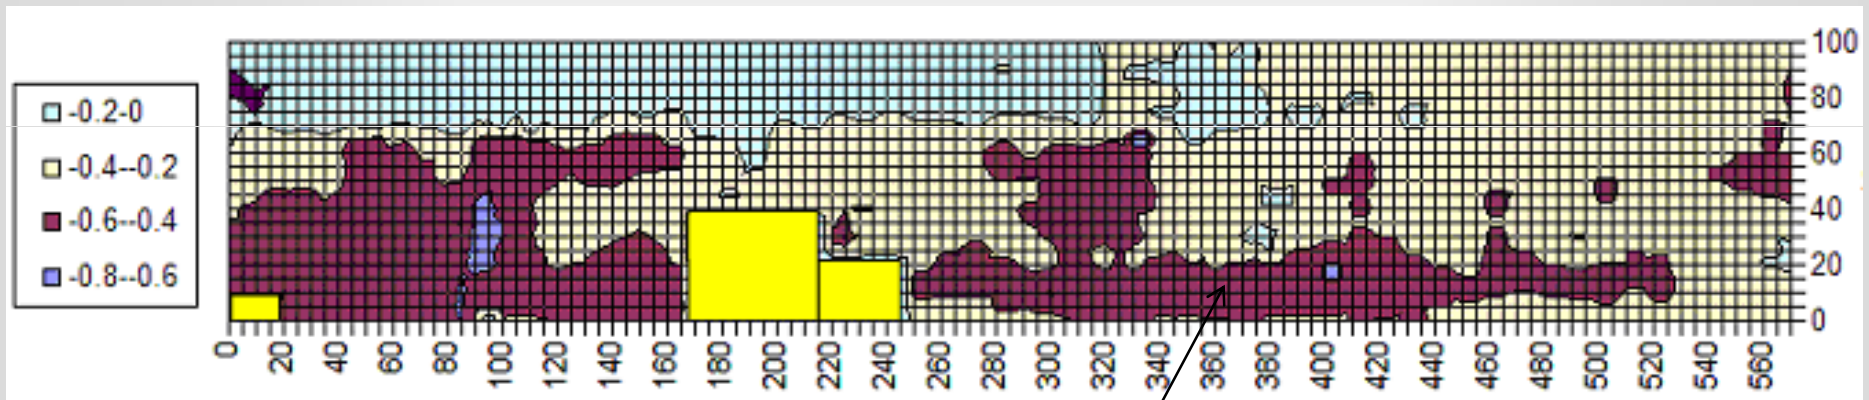
560' x 100' void & elevation survey

The darker outlines indicate the void area

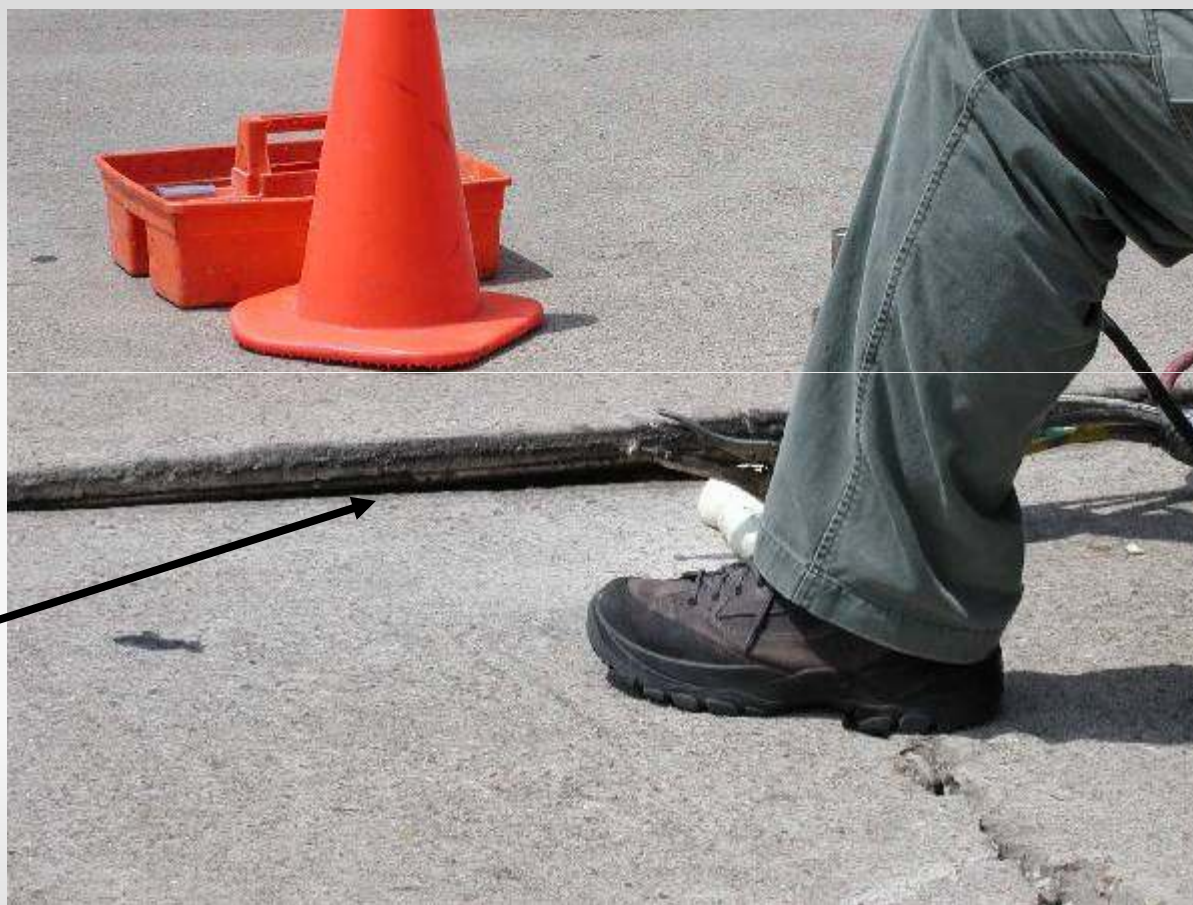
Visible settlement

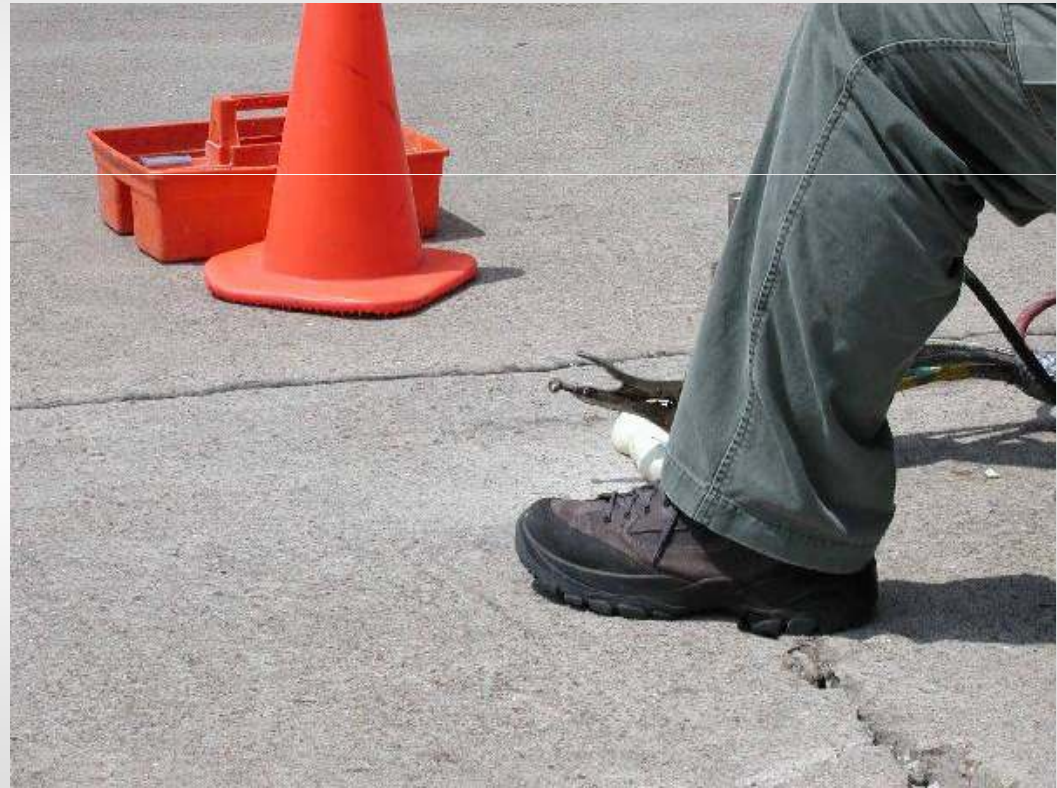
After lifting the slab

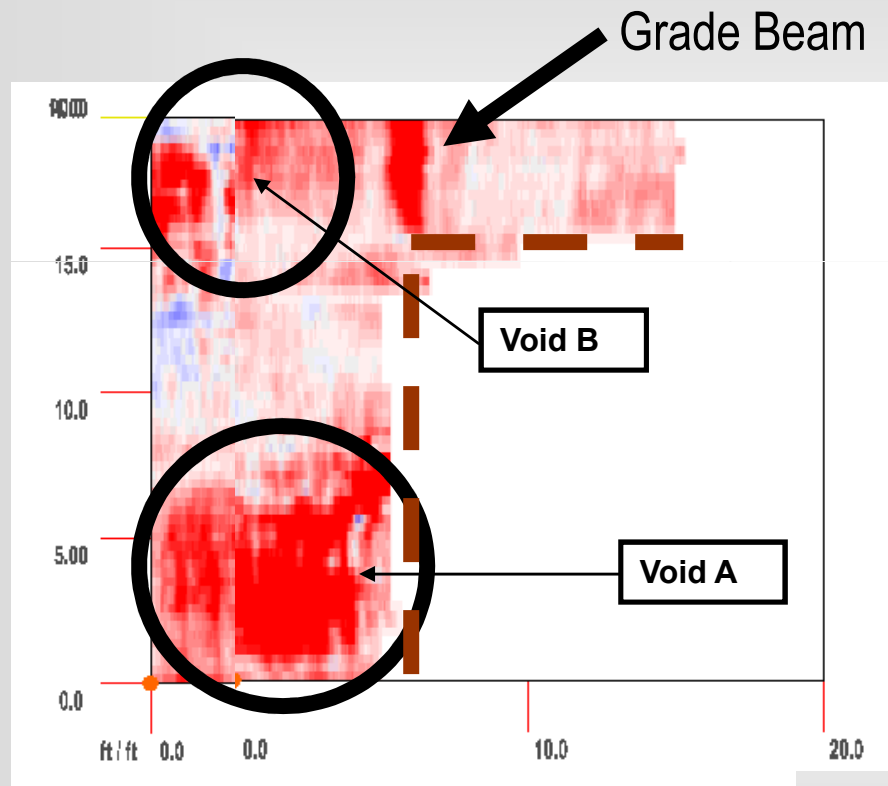
Voids were found in two locations
Geotechnical Engineering Review
Determined the cause to be
poor compaction of fill
A contractor was mobilized to
pump flowable fill into the voids

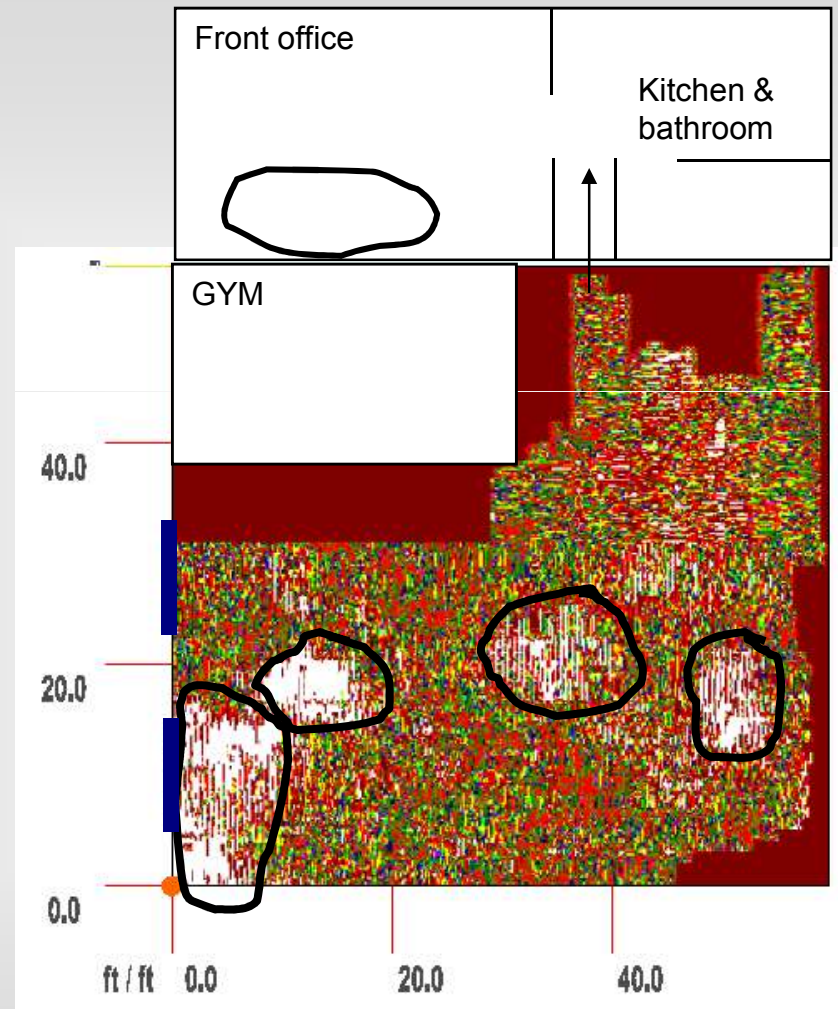
Client observed settlement in the offices and warehouse floor. The visible settlement was about 1-2".

The black outlines indicate the void locations.

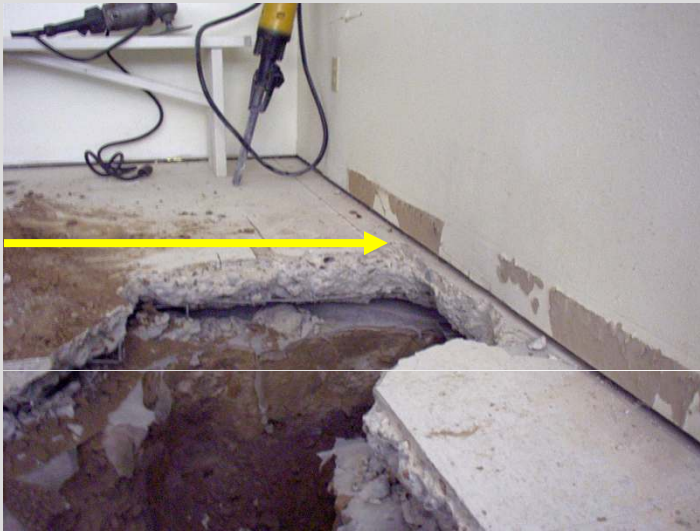
Front office slab was broken out to verify the void and repair utilities.

Voids are evident throughout the scan (2-3" deep).

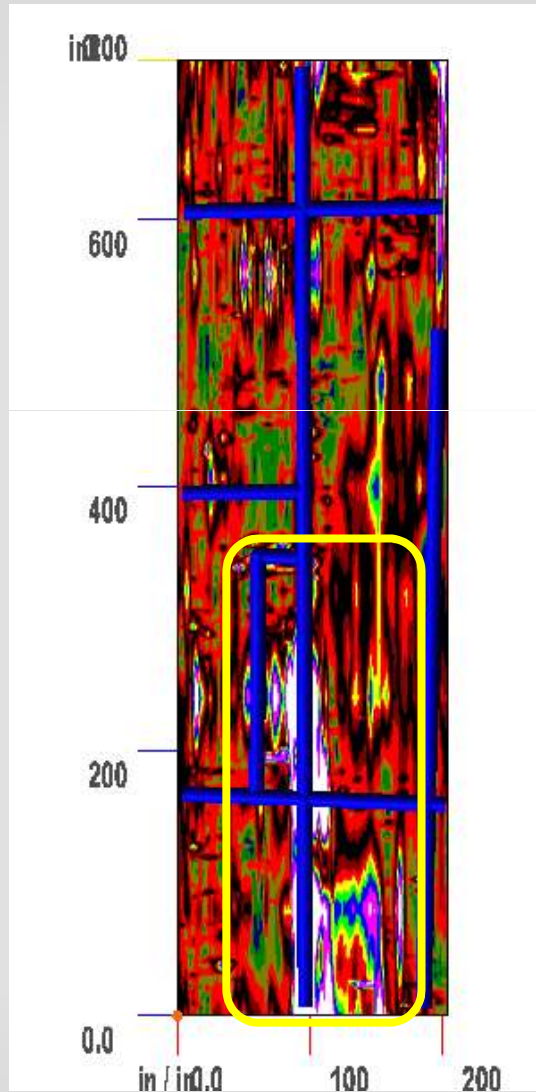
The image to the left shows pipes detected as well as a leaking connection and void.

The void and saturated soil from the leak are outlined in yellow.

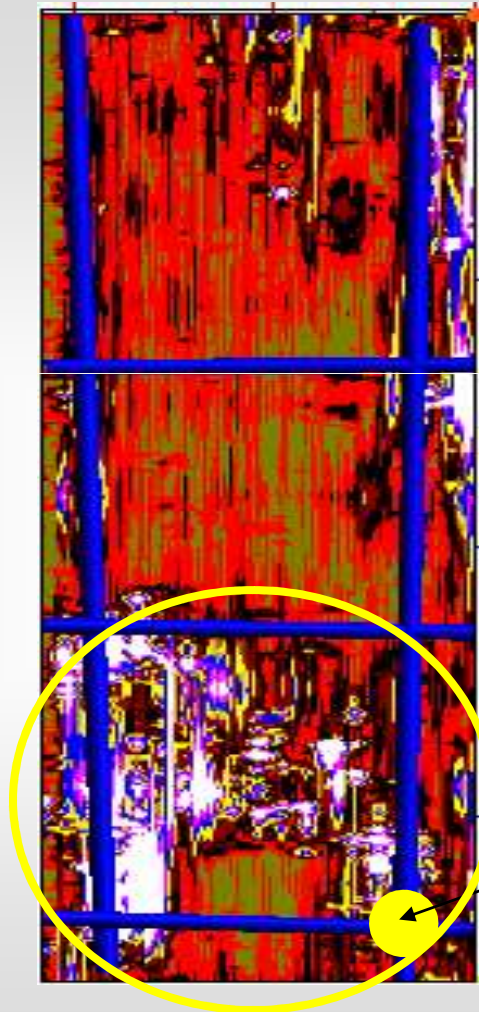
Manhole

The image to the right shows the pipes detected as well as a leaking manhole and void.

The void and saturated soil from the leak are outlined in yellow.

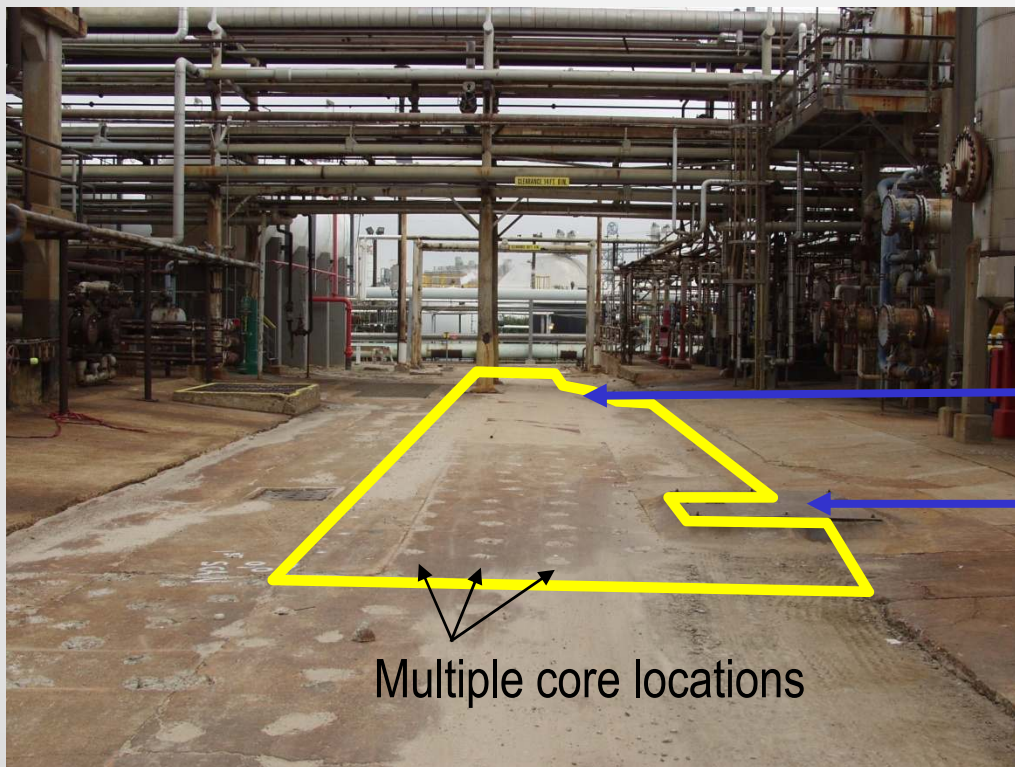
Problem: Concern about placement of a large crane in the roadway and general vehicular traffic safety due to a pothole. The pothole was the least of the problems. A core sample program was started first and did not find any problems. The client heard about our void imaging services and requested a 2nd look.

Existing Pothole

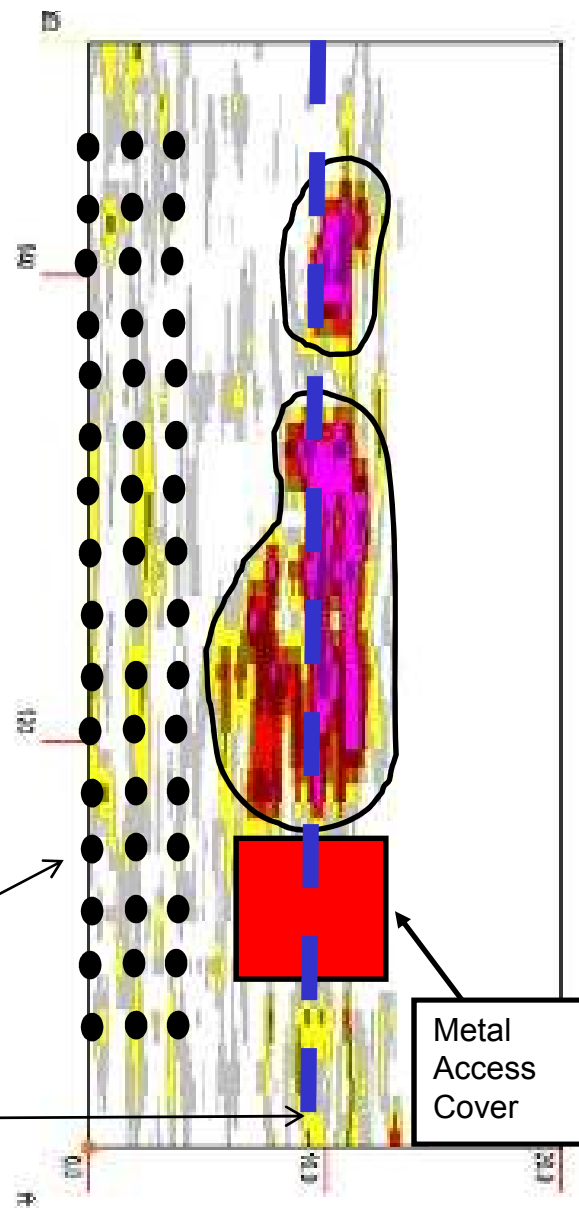
As evident in the image, the core sample program missed the large voids entirely.

Voids Found

5' x 2' x 2' deep

18' x 7' x 2' deep

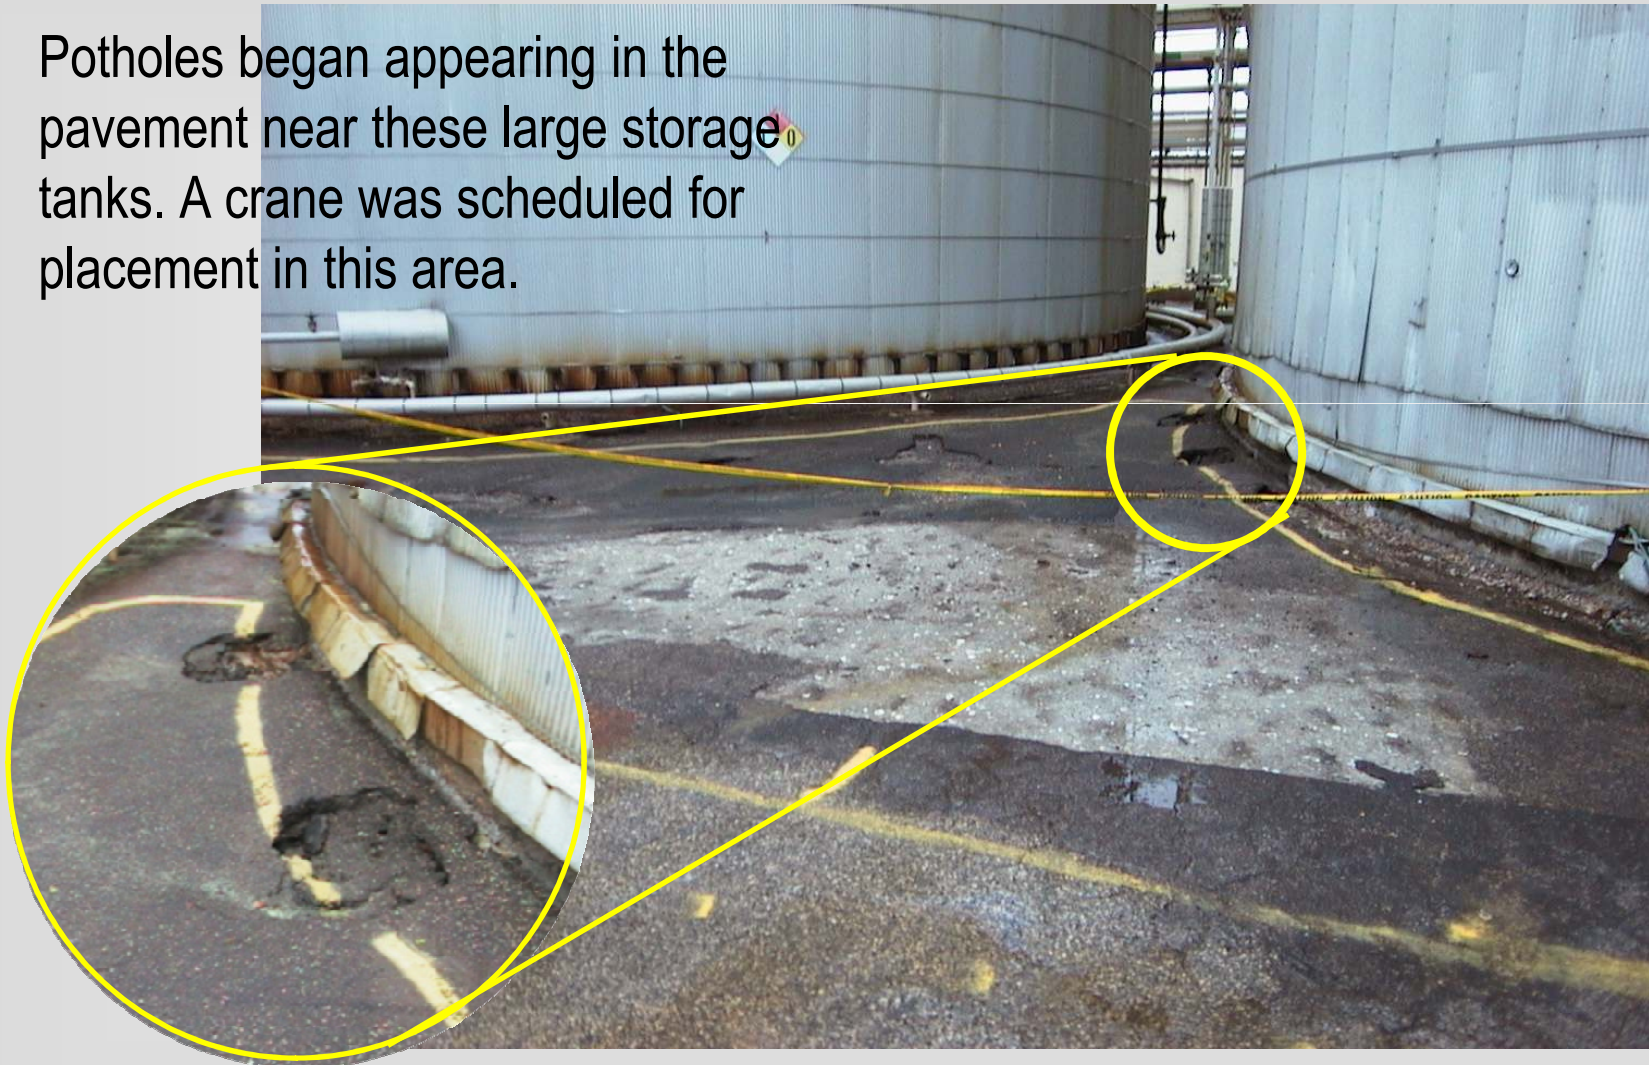
Settlement of pavement around storage
tanks within an industrial facility

Potholes began appearing in the pavement near these large storage tanks. A crane was scheduled for placement in this area.

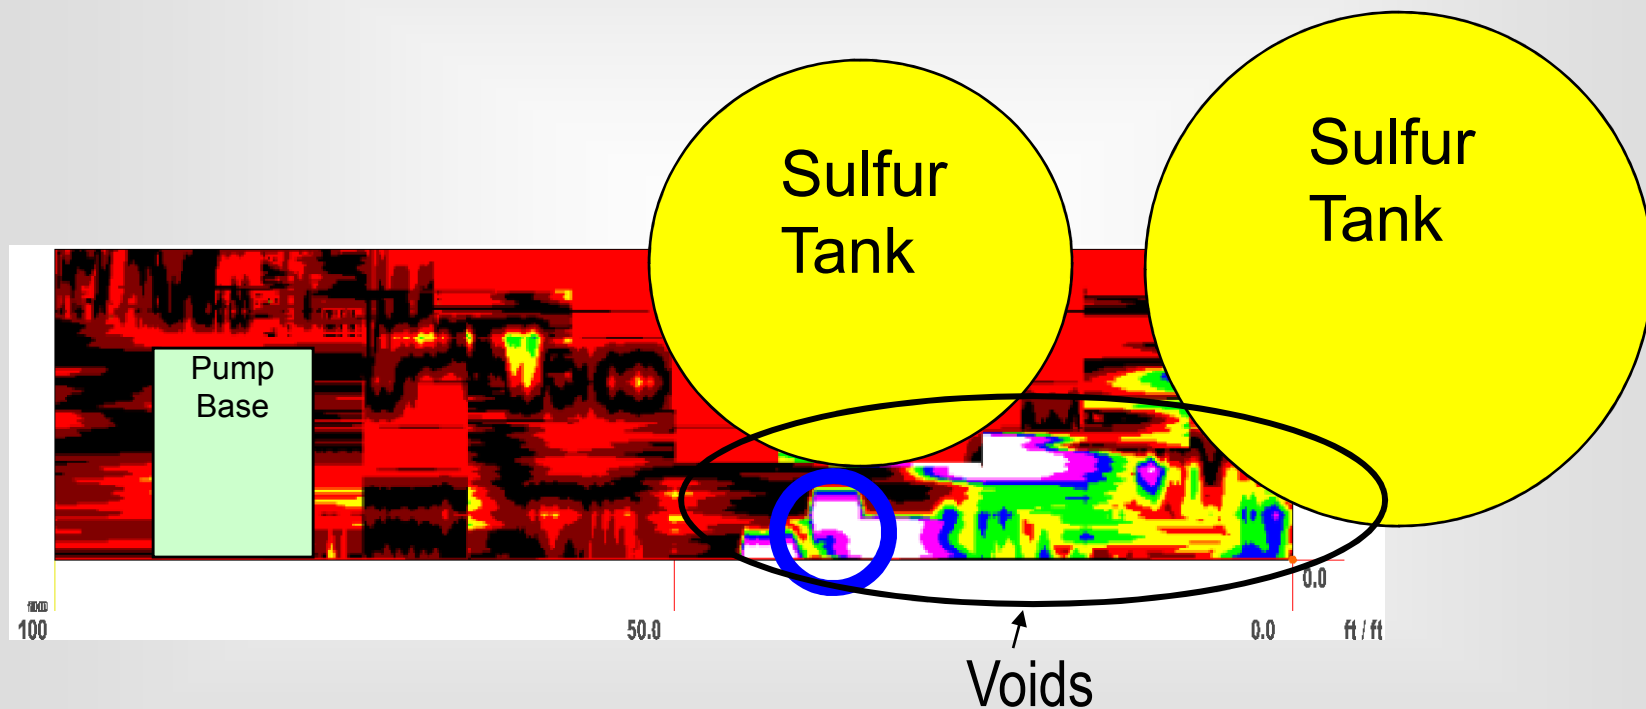
The outline below shows the intermittent void area detected beneath the pavement. Erosion of soil from a nearby leaking acid cooling tower was the cause.

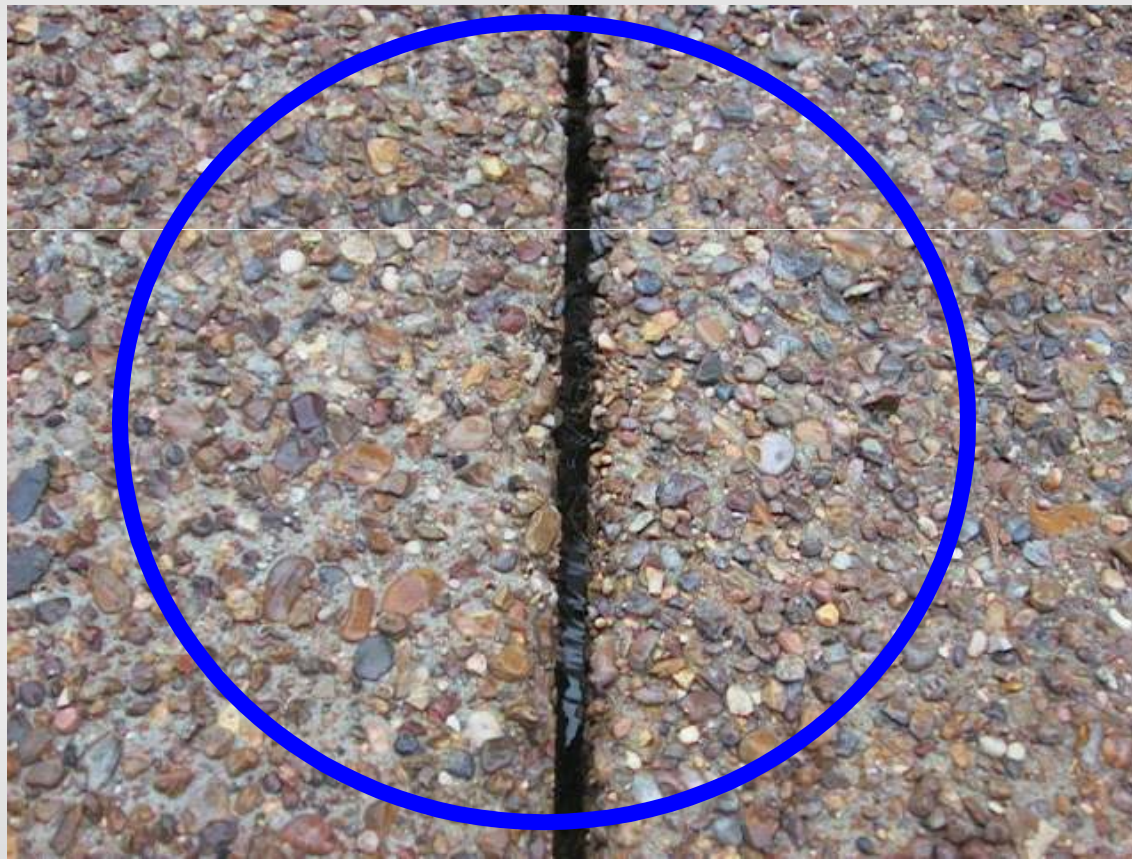
Leaking Cooling Unit eroded the soil underneath the pavement and deteriorated the concrete as well.

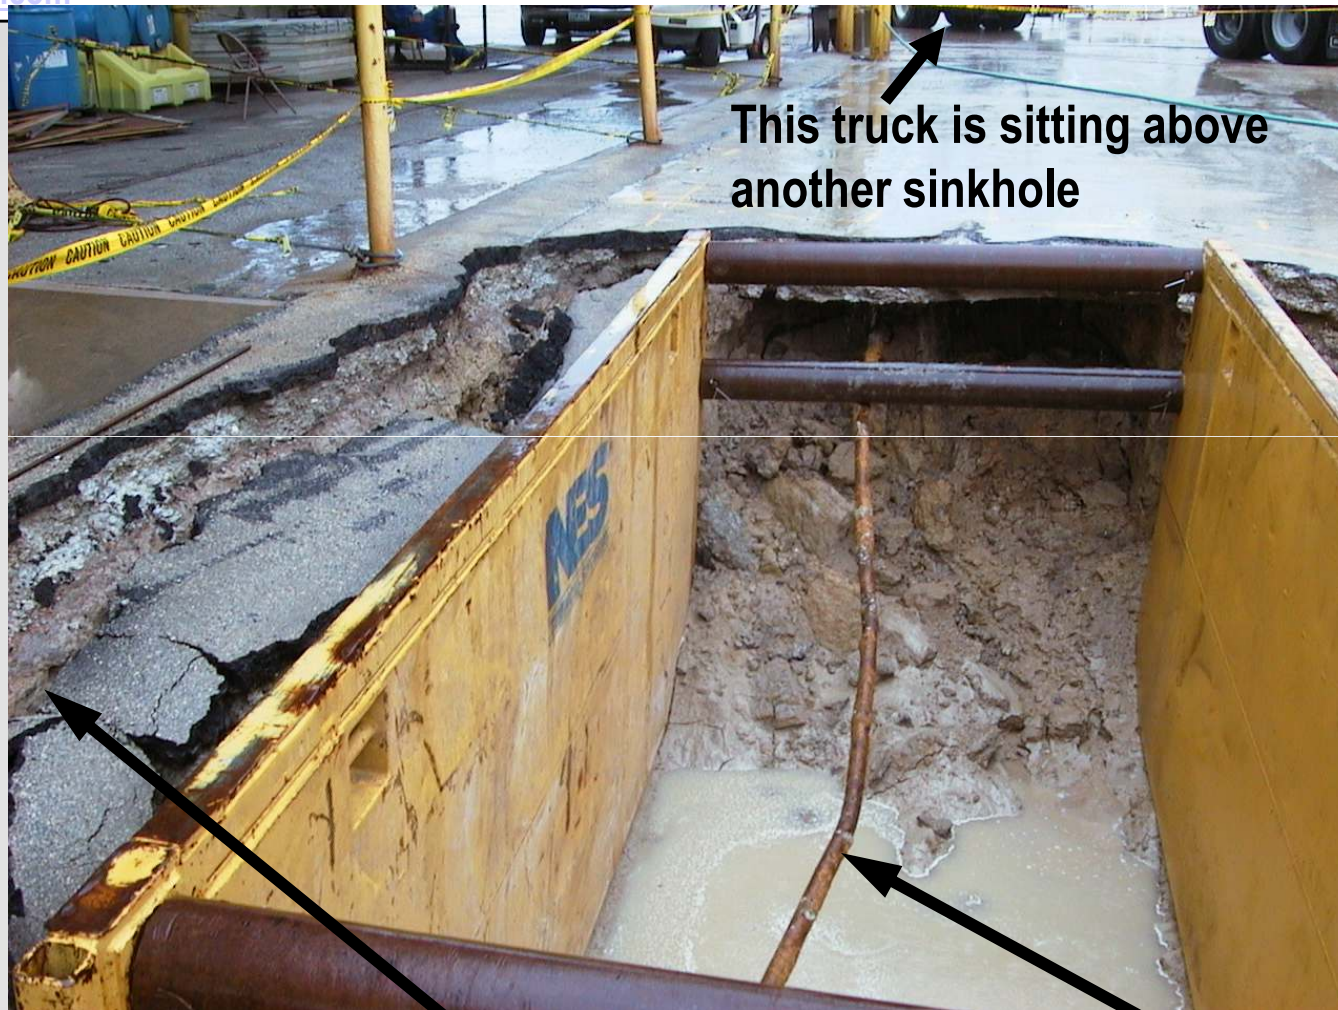
This truck is sitting above another sinkhole

6" Clay Water Pipe

2" Gas Pipe

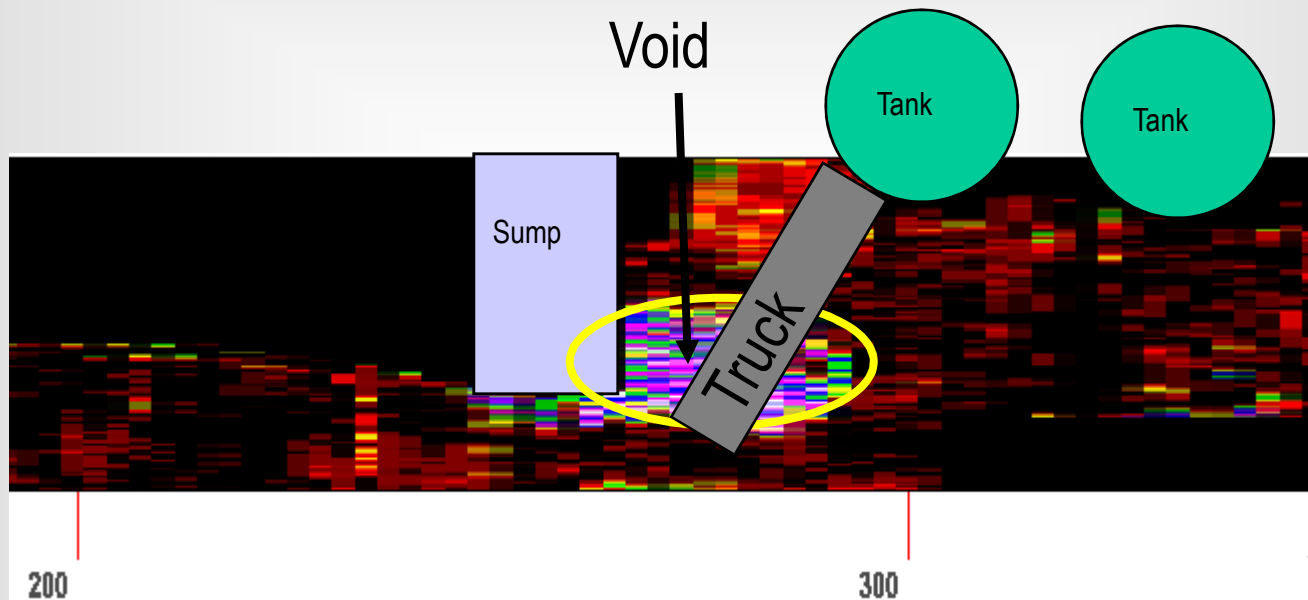
The truck that was shown two slides before is outlined below. Another large void was detected where the truck was parked.

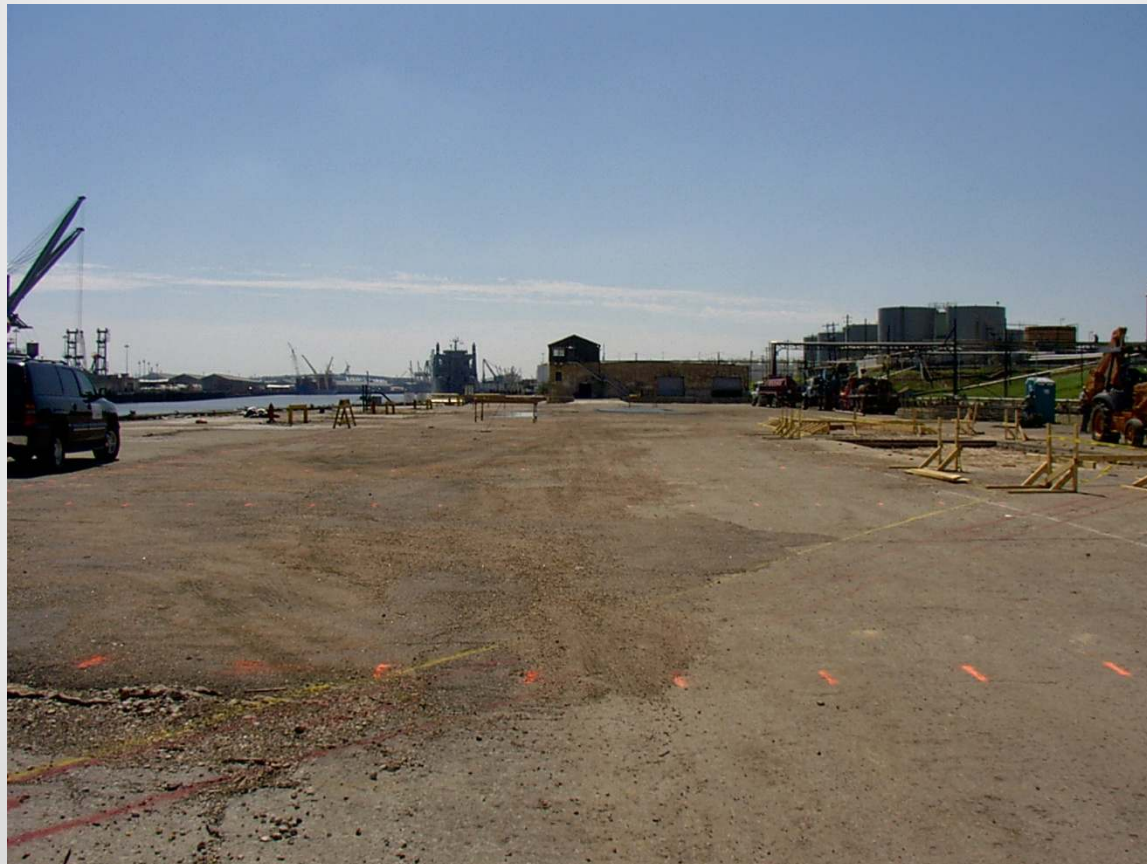
This wharf had some visible depressions present and one pothole. The owner had leased the spaced for 3 new cement silos. Concern about the heavy loads prompted a void survey.

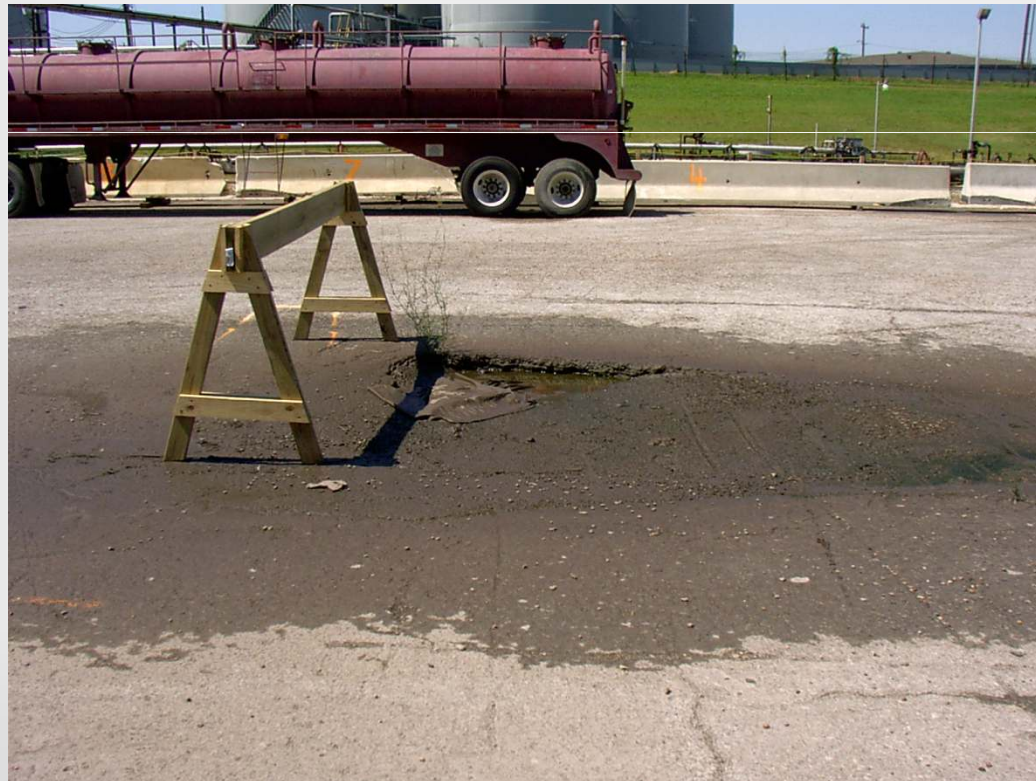
Pot holes tell you that a larger problem may exist below ground.
Note the heavy truck traffic in the area.

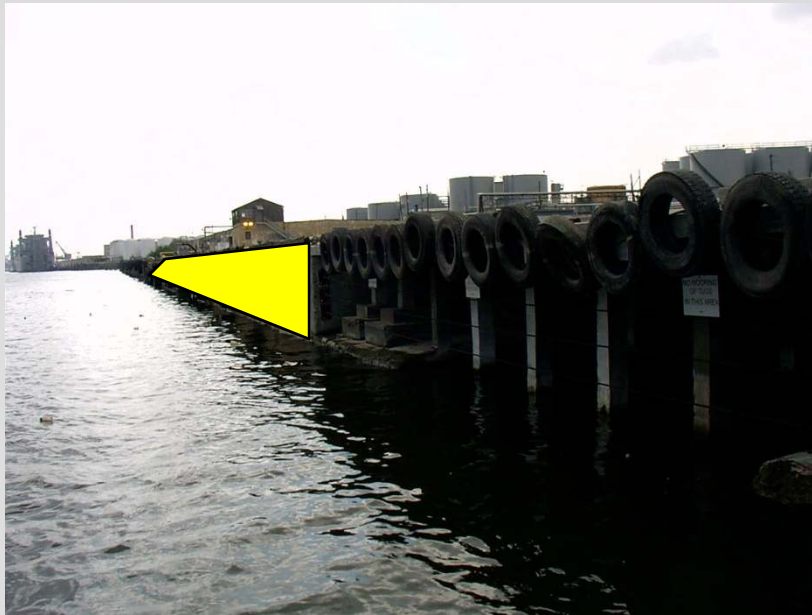
This concrete bulkhead was examined for voids – work was performed from a boat. The area in yellow to the left was examined and the data image below shows the void in an elevation view.

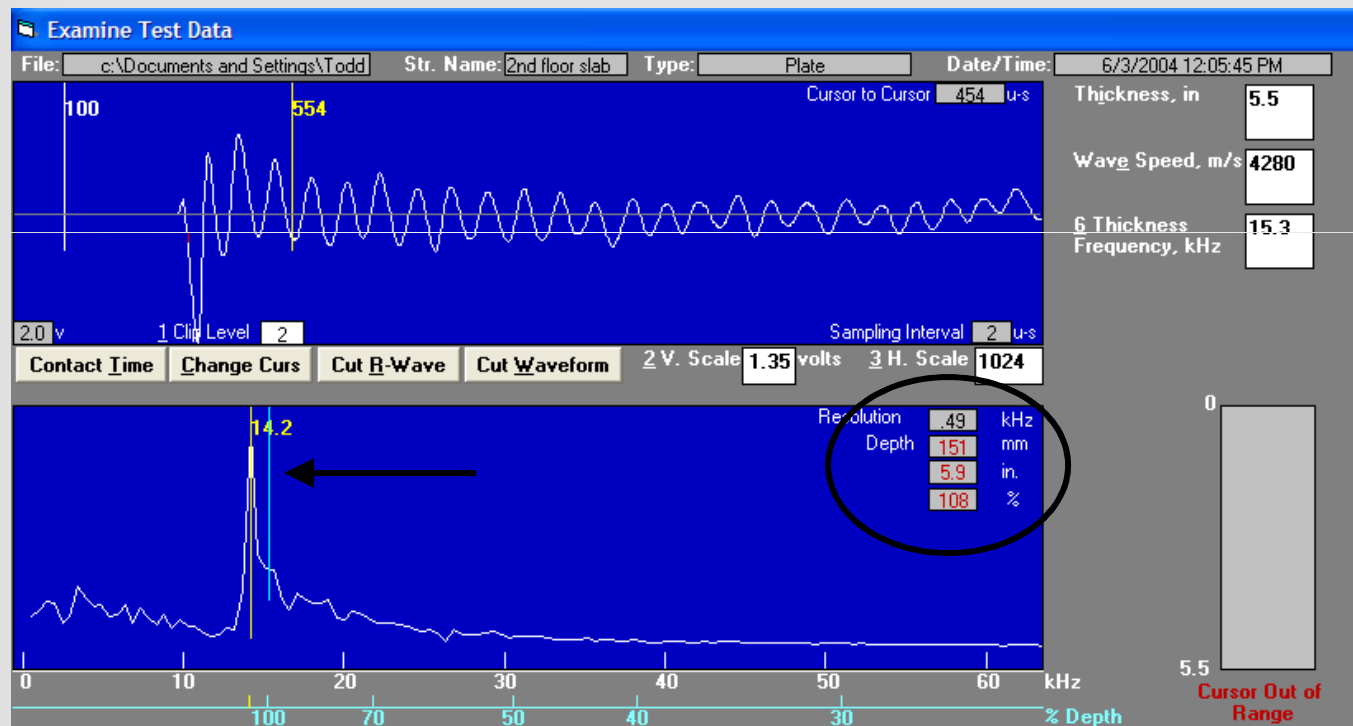
Thickness frequency analysis > 14.2 kHz > 5.9" thick

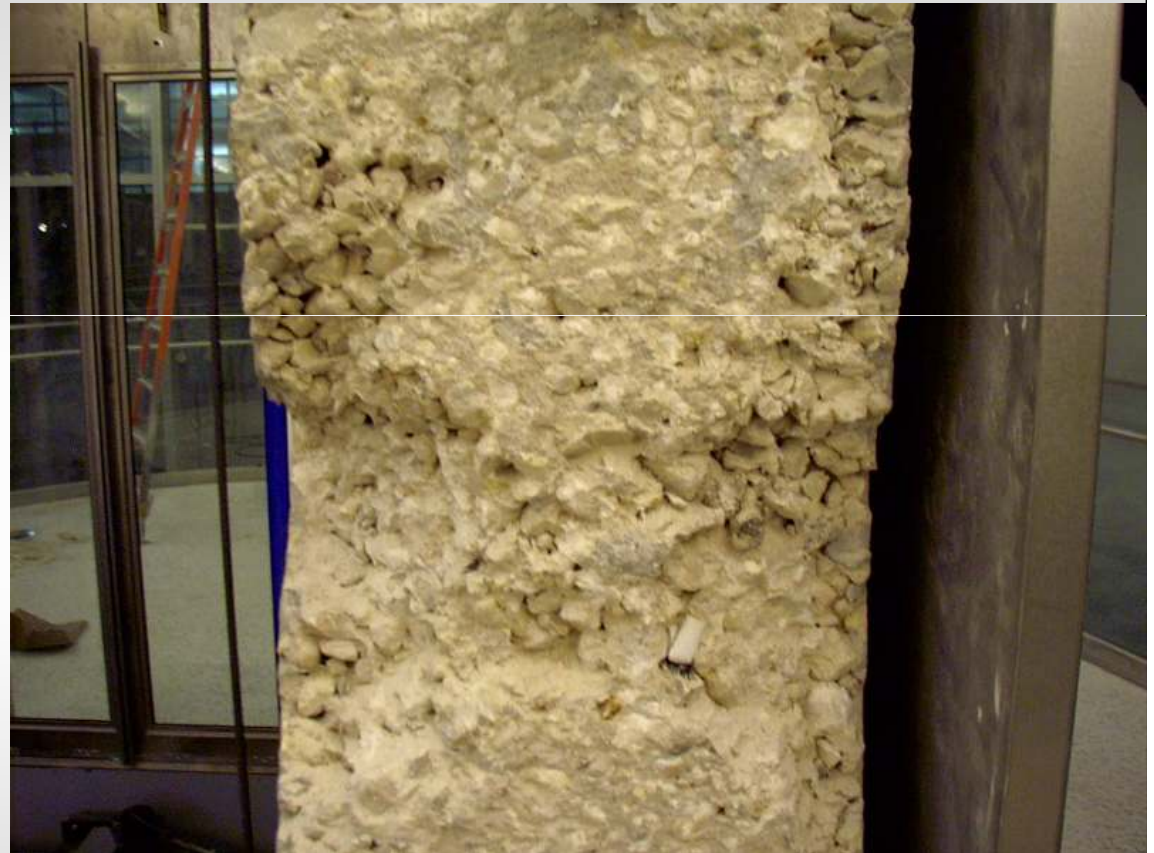
When the forms were removed from this concrete wall, it was apparent that there were quality problems with the concrete mix.

Honeycombs/voids were seen visually. An examination was requested to see if the entire wall was affected. In the end the wall was repaired by injection with epoxy.

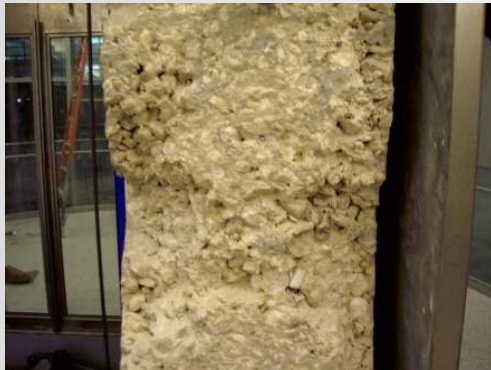
Poor consolidation
